# Special Session on 2023 Turkey Earthquake Sequence

## Field Observations on Structural Performance of Public Buildings in Turkey

**Assoc. Prof. Zeynep Tuna Deger**

Istanbul Technical University

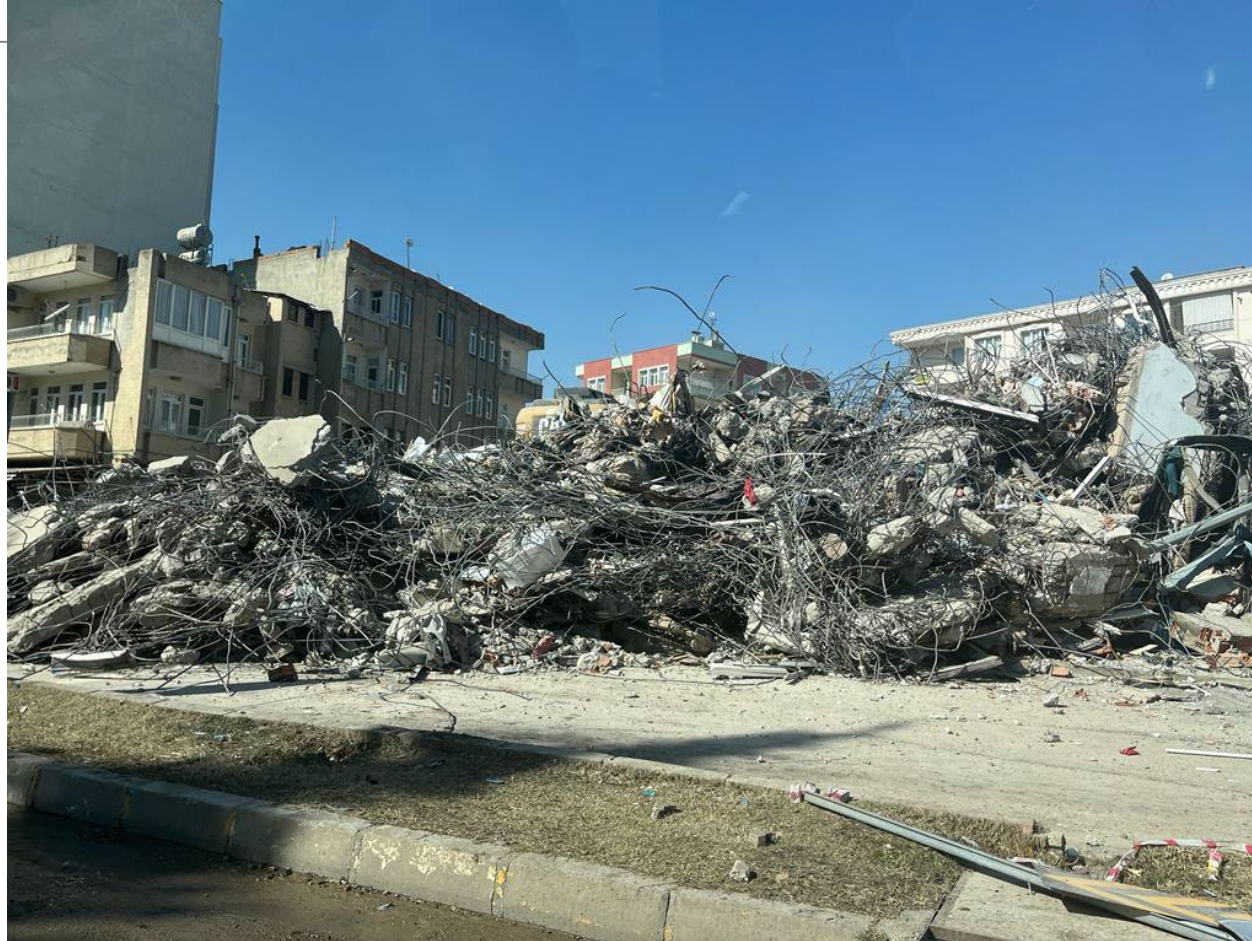
# Field Trip Highlights: - Poor Material Quality

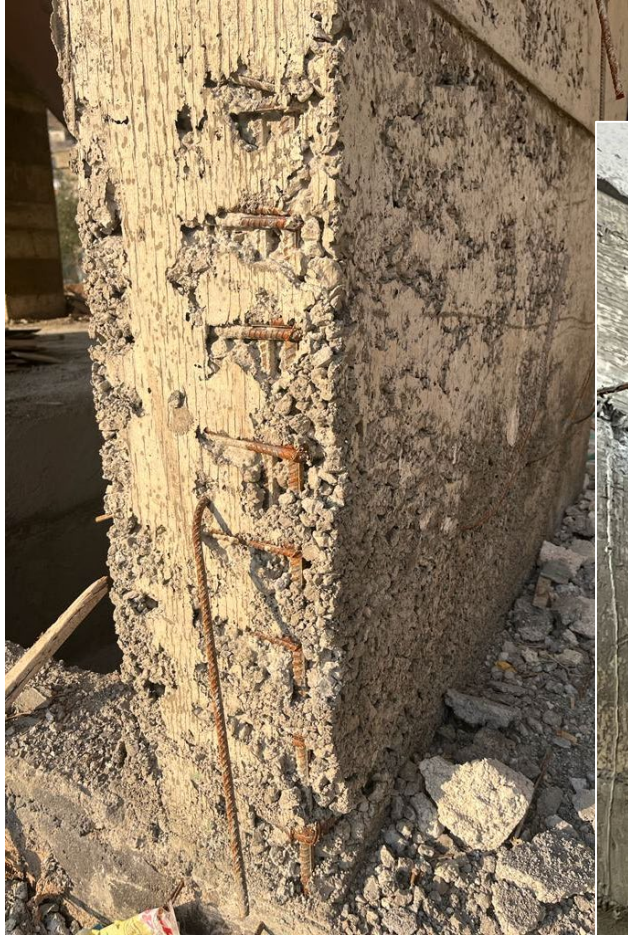
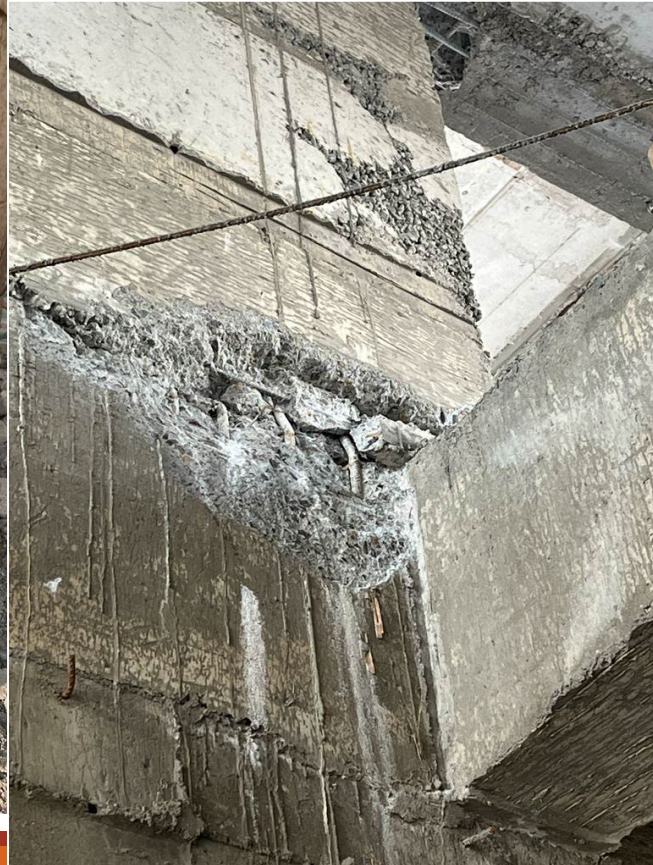
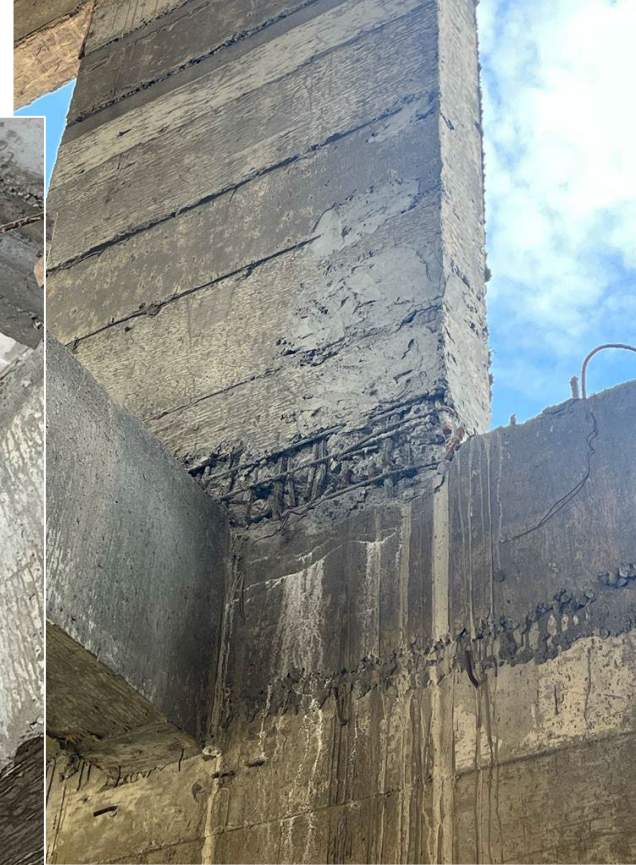
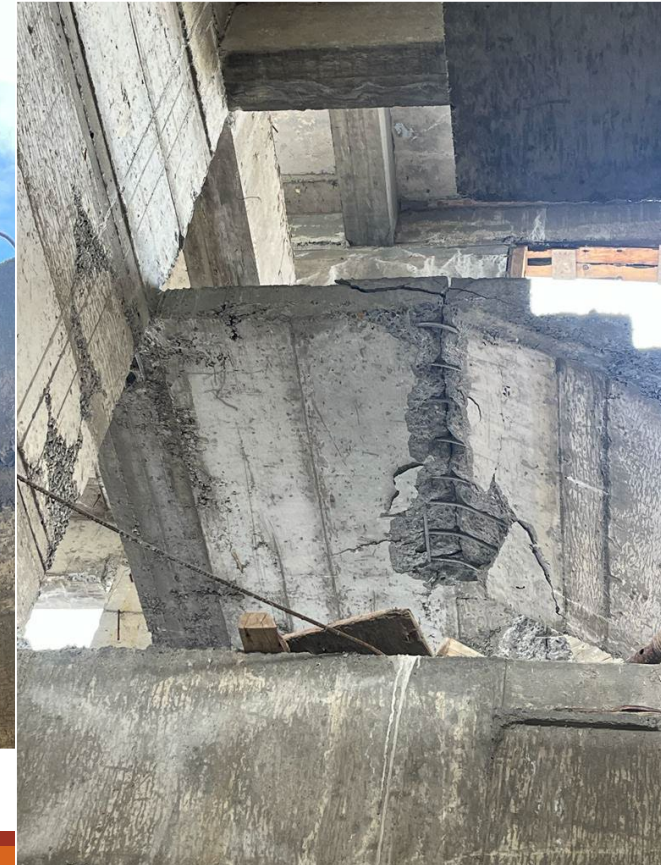
- Lack of proper concrete work and formwork construction

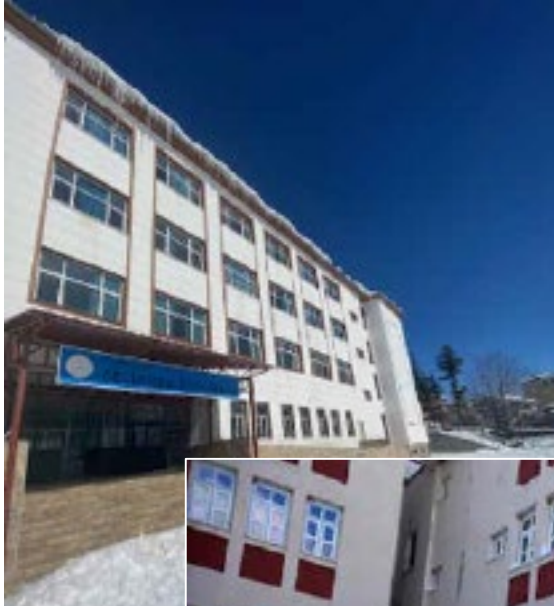
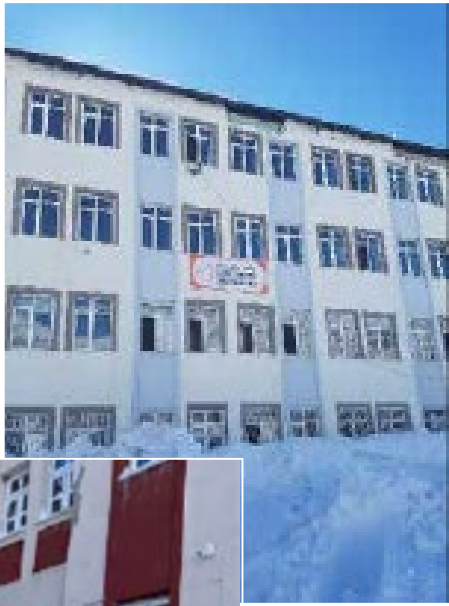
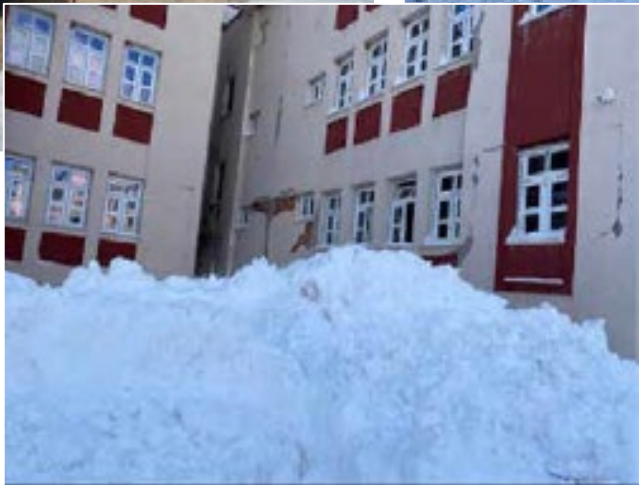
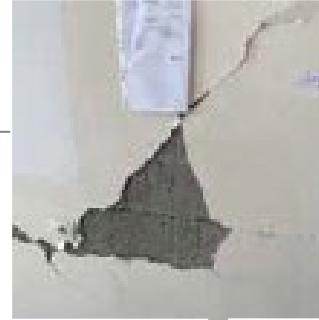
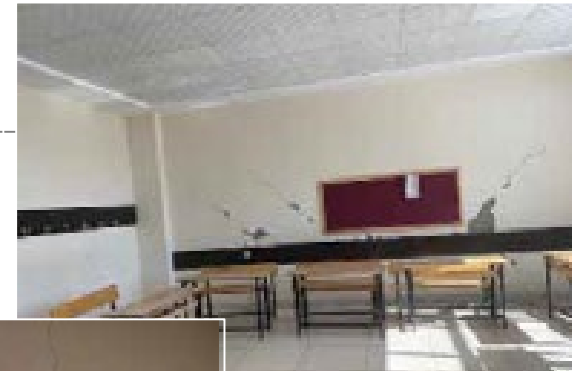
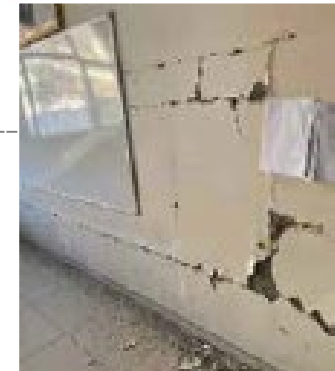
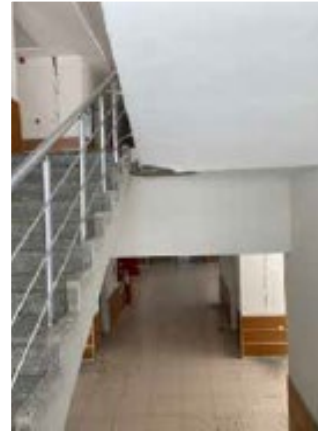
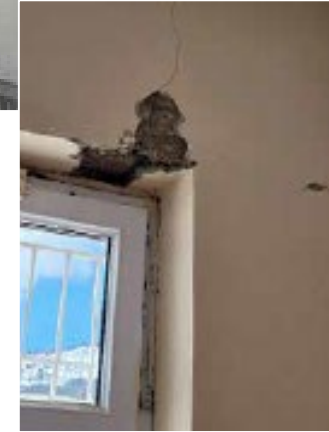
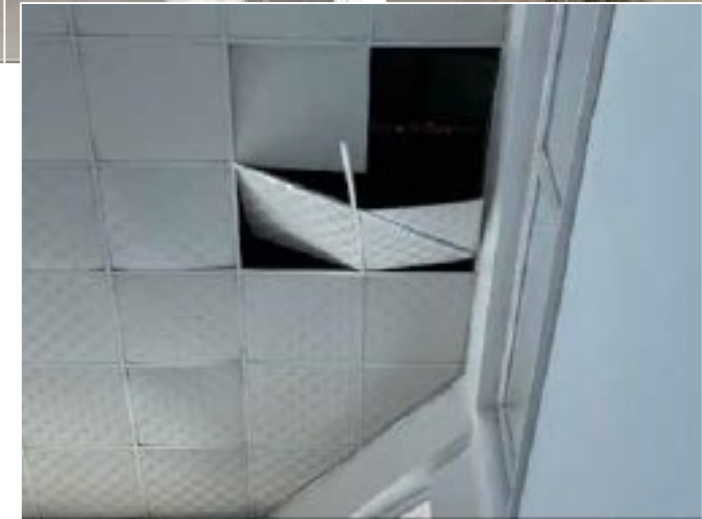
## Adiyaman

- Spalling of exterior cladding
- Cracks in infill walls and plasters
- Damage in stairways
- Nonstructural damage

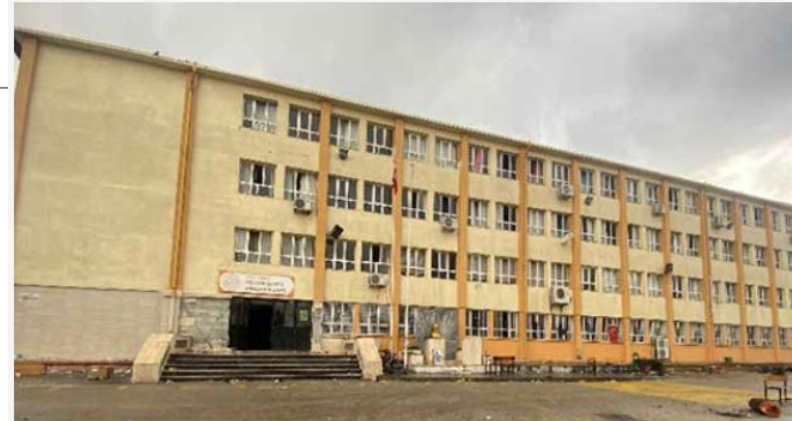
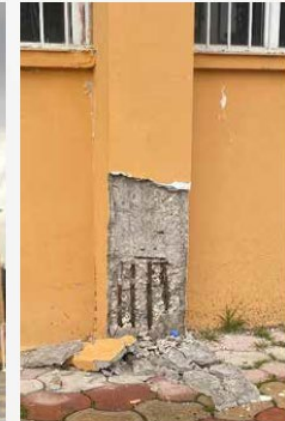
Columns – longitudinal bar buckling

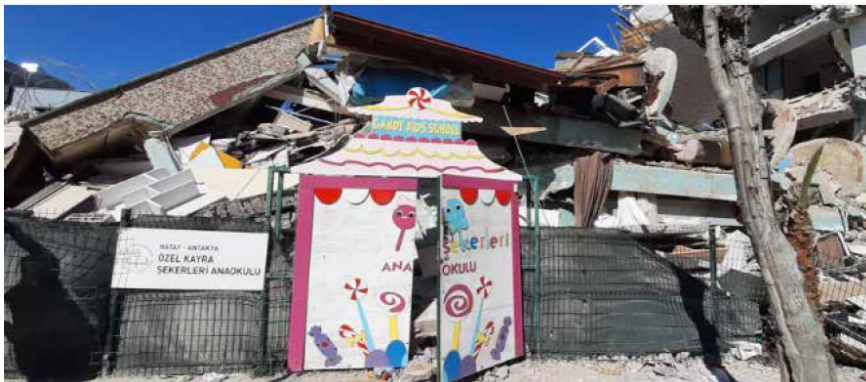
Pancake-style complete collapse

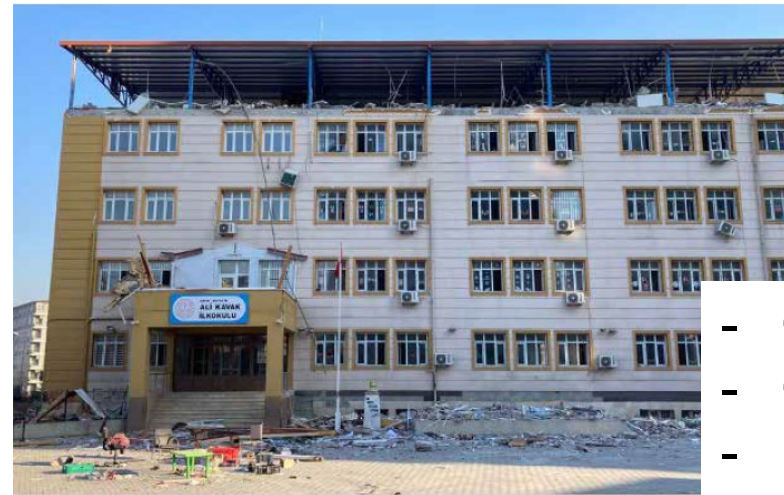
- Collapse of infill walls
- Ceiling damage
- Nonstructural damage

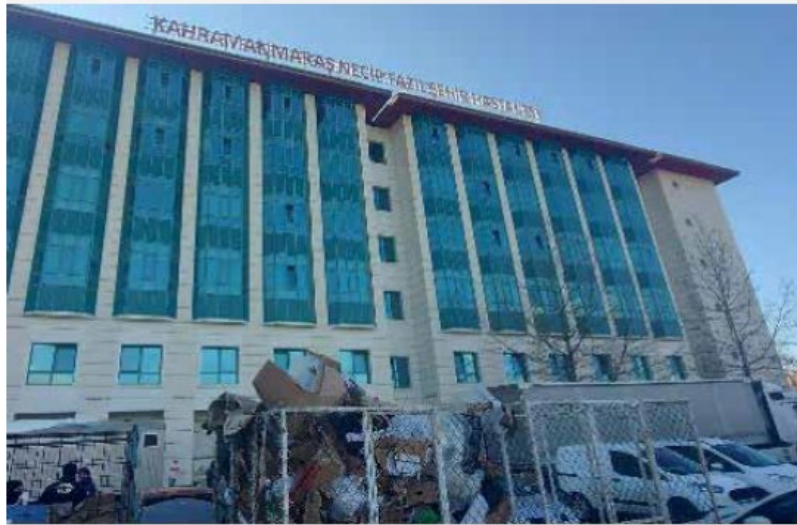
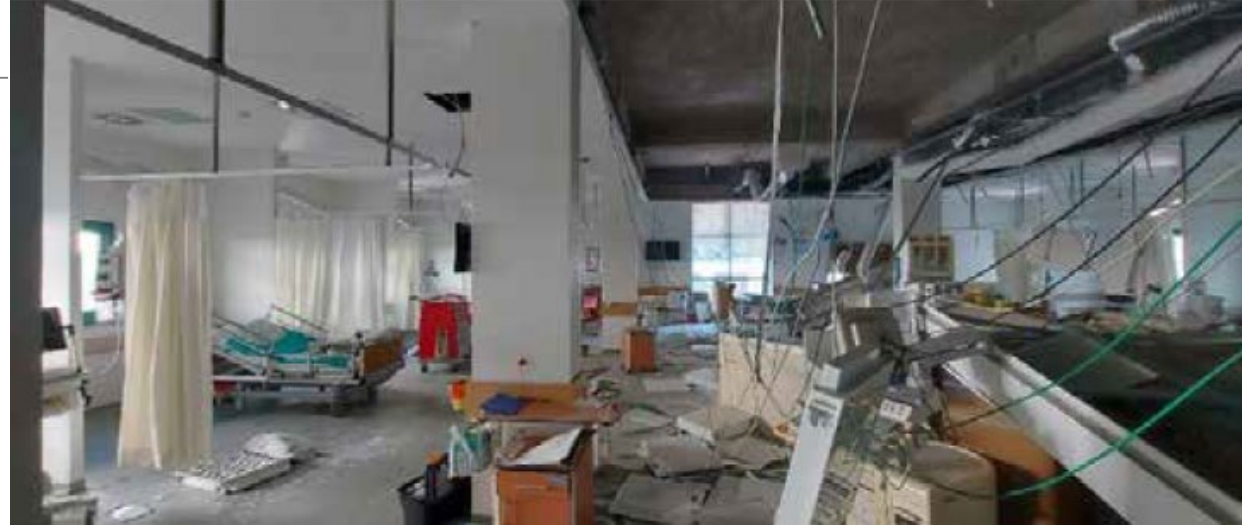
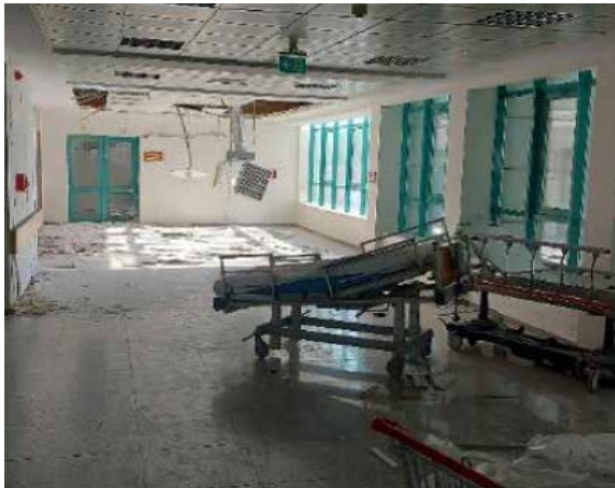
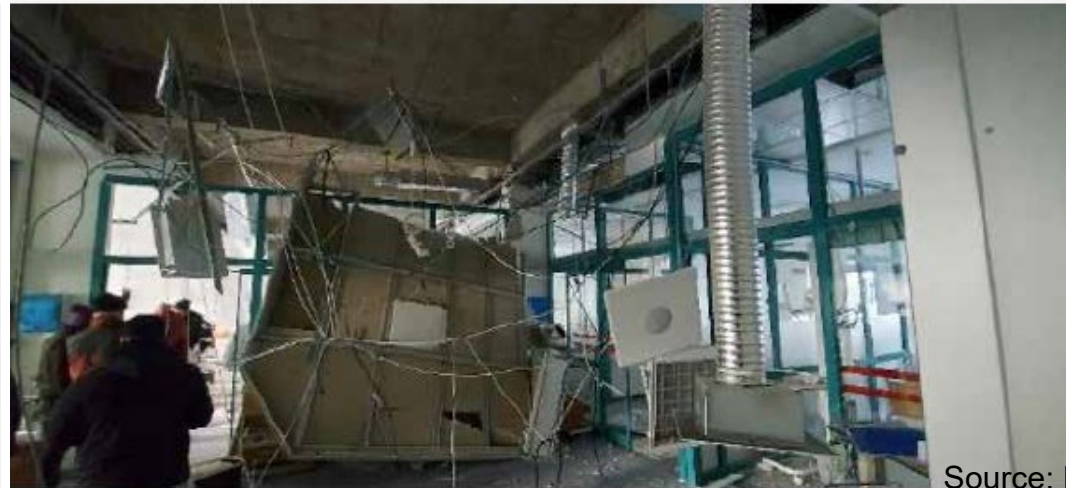
## Kahramanmaras, Public Hospital

- Spalling of exterior cladding
- Nonstructural damage
- Cracks in infill walls
- No structural damage

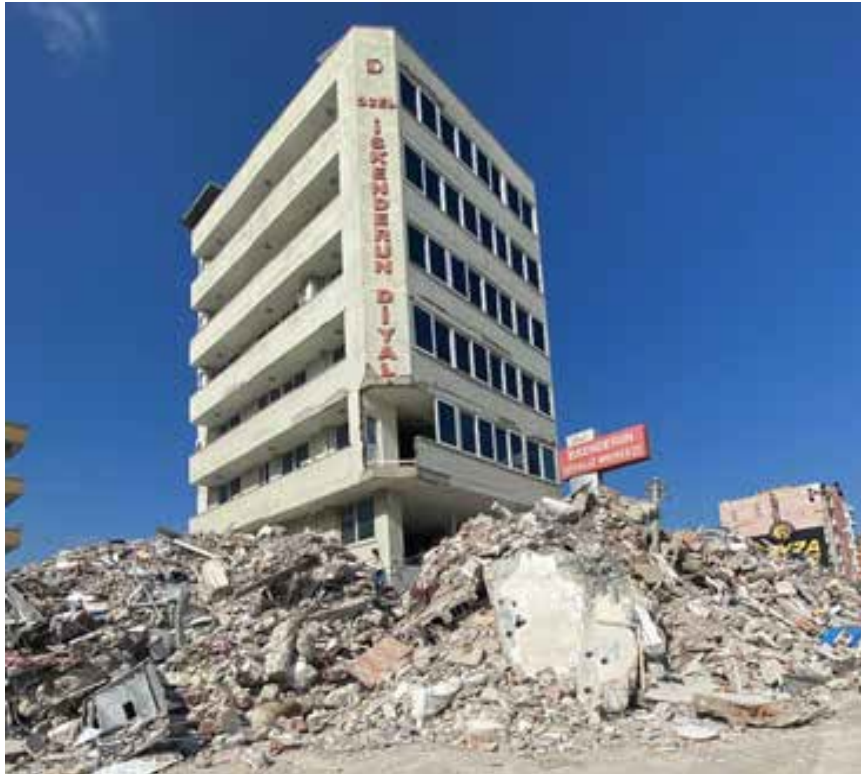
**Private Dialysis Center**  
Damaged but standing!

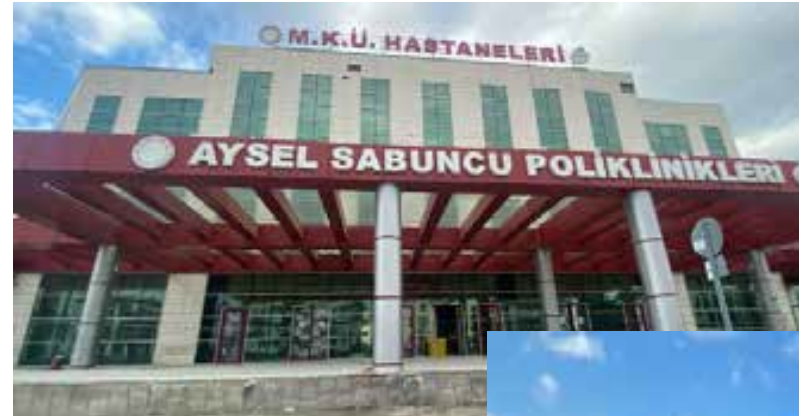
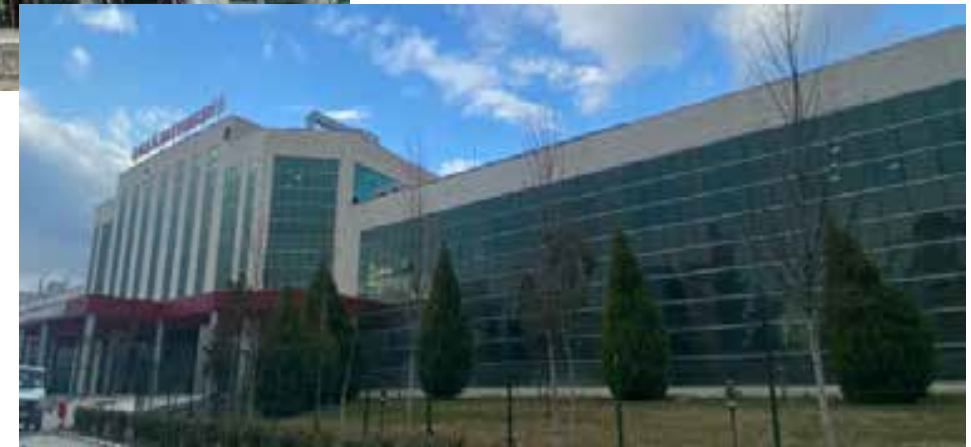
**Public Hospital**  
Damage only in exterior cladding.

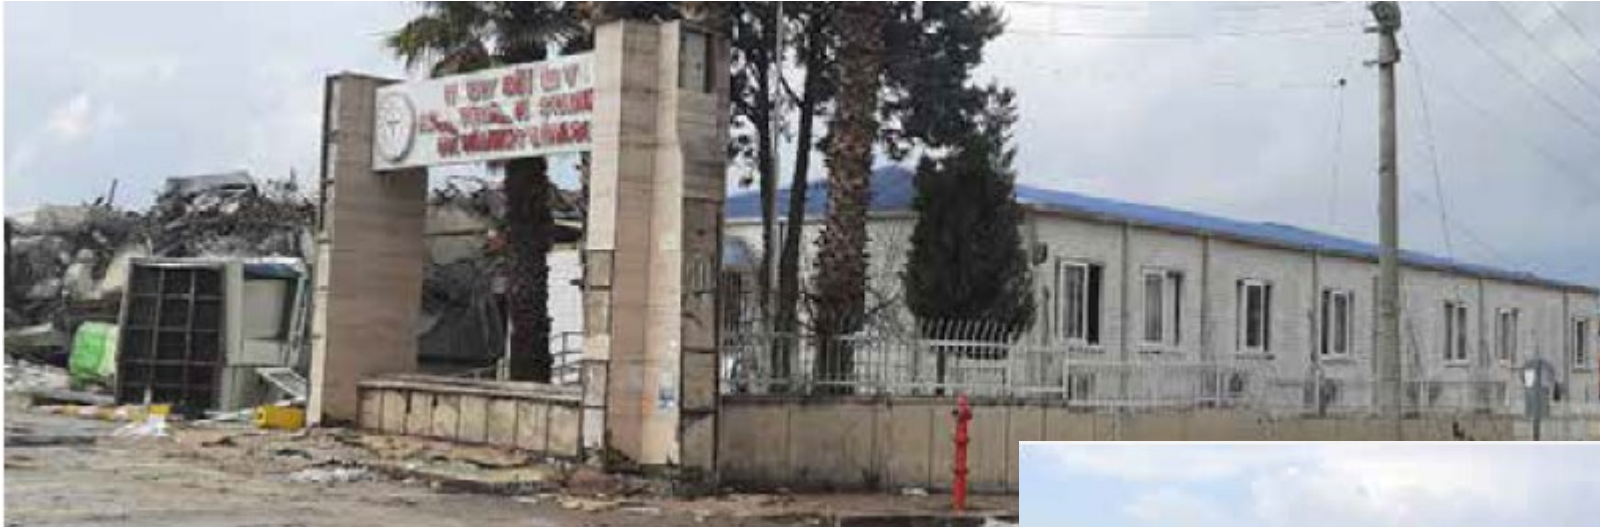
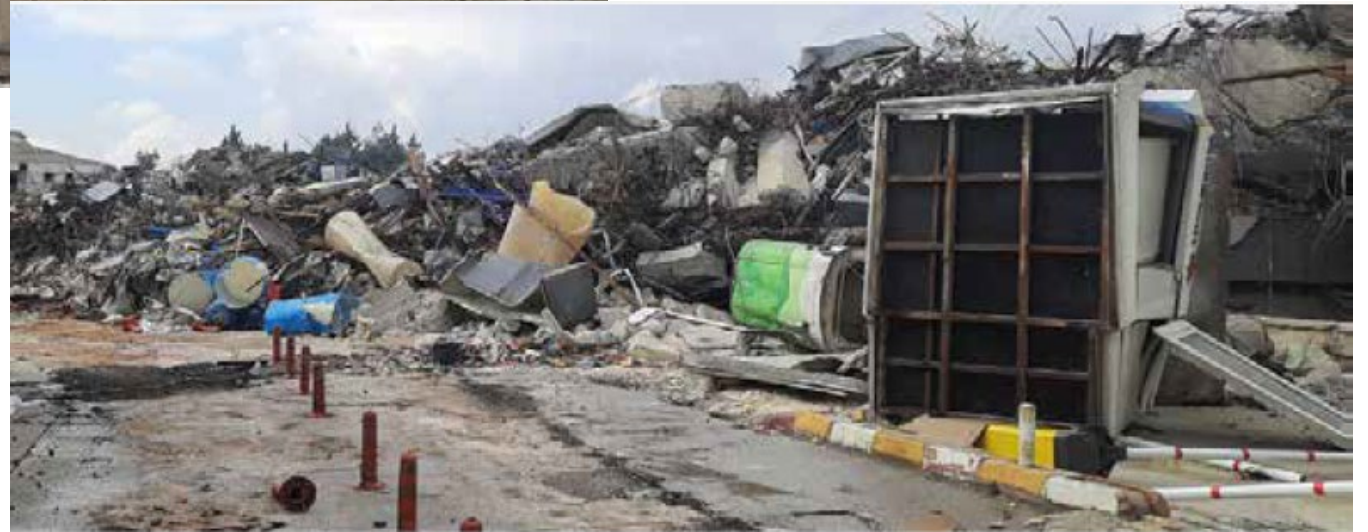
## Hatay, Public Hospital

**Completely collapsed!**

- Substandard reinforcement
- Poor concrete quality

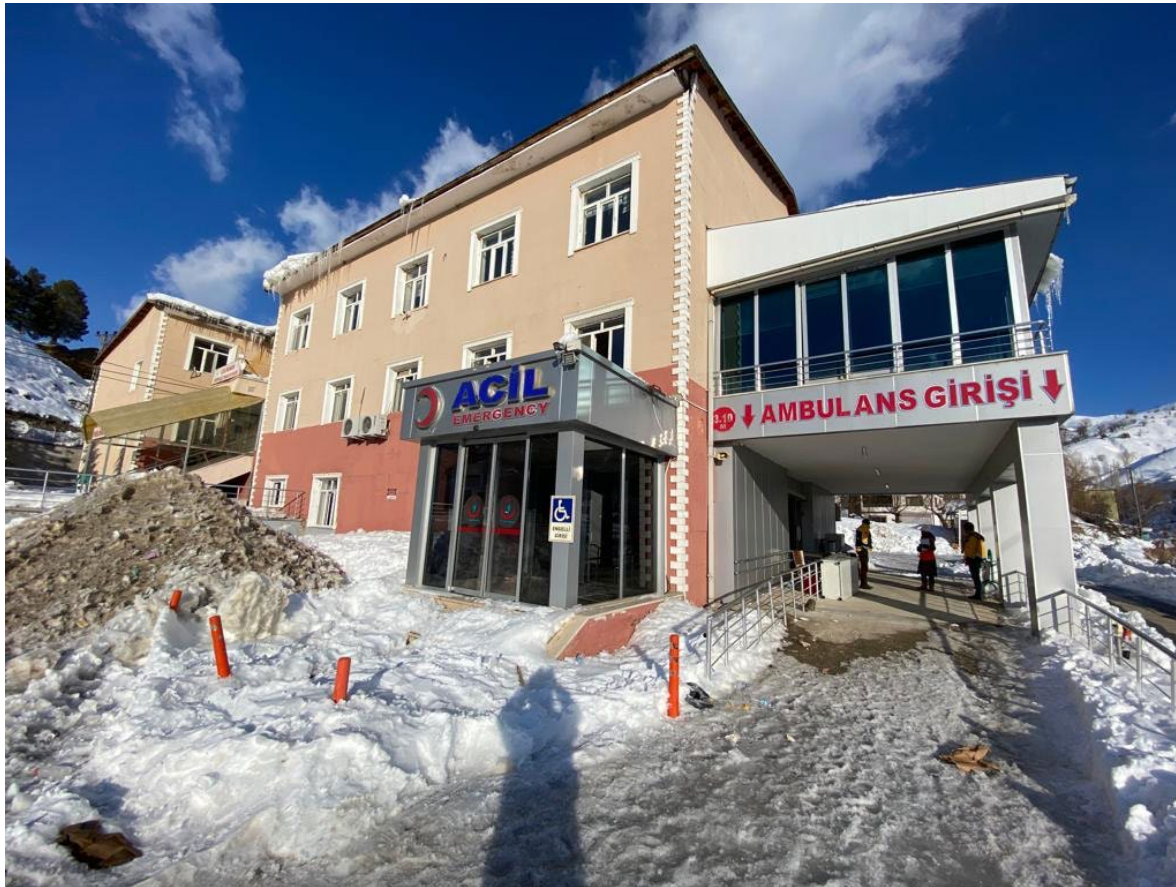
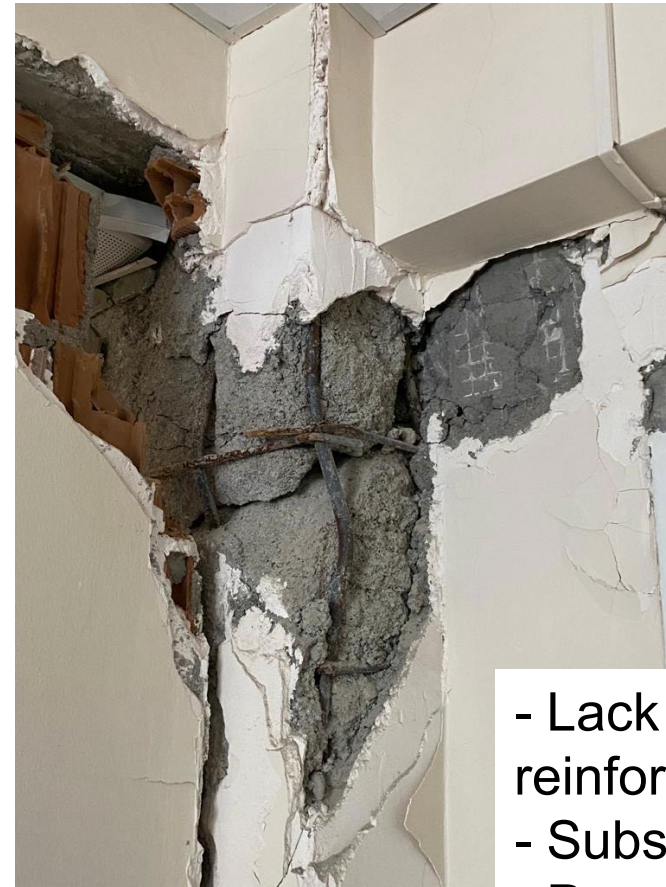
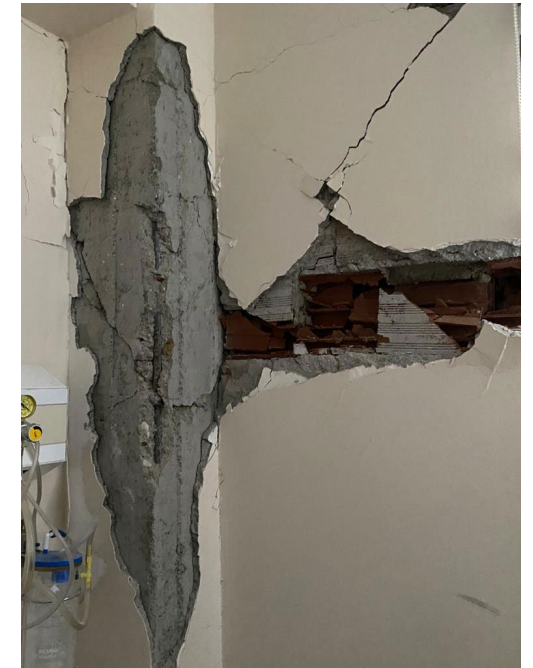
## Adiyaman, Public Hospital

- Lack of sufficient transverse reinforcement
- Substandard reinforcement
- Poor concrete quality

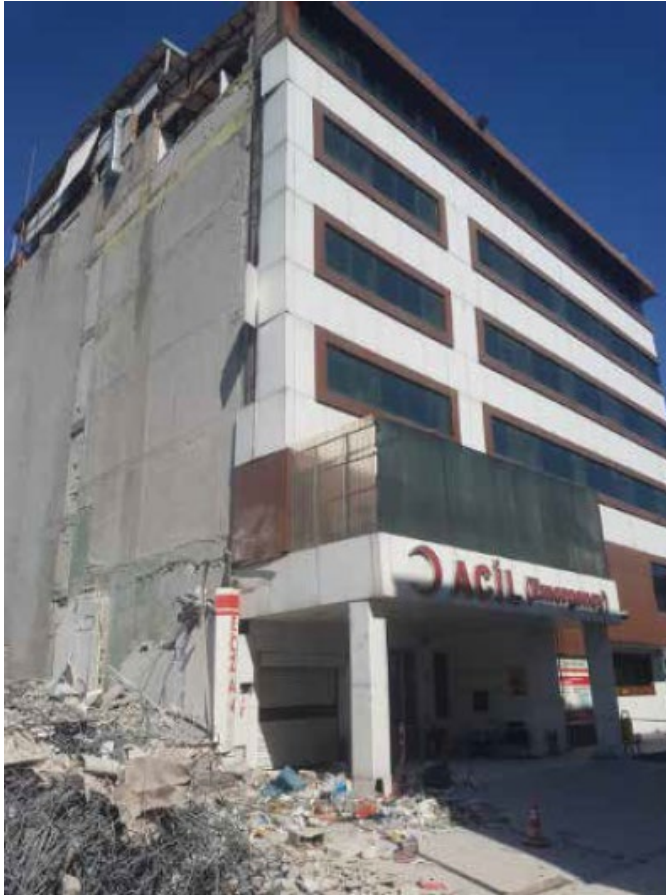
Exterior - next building is collapsed

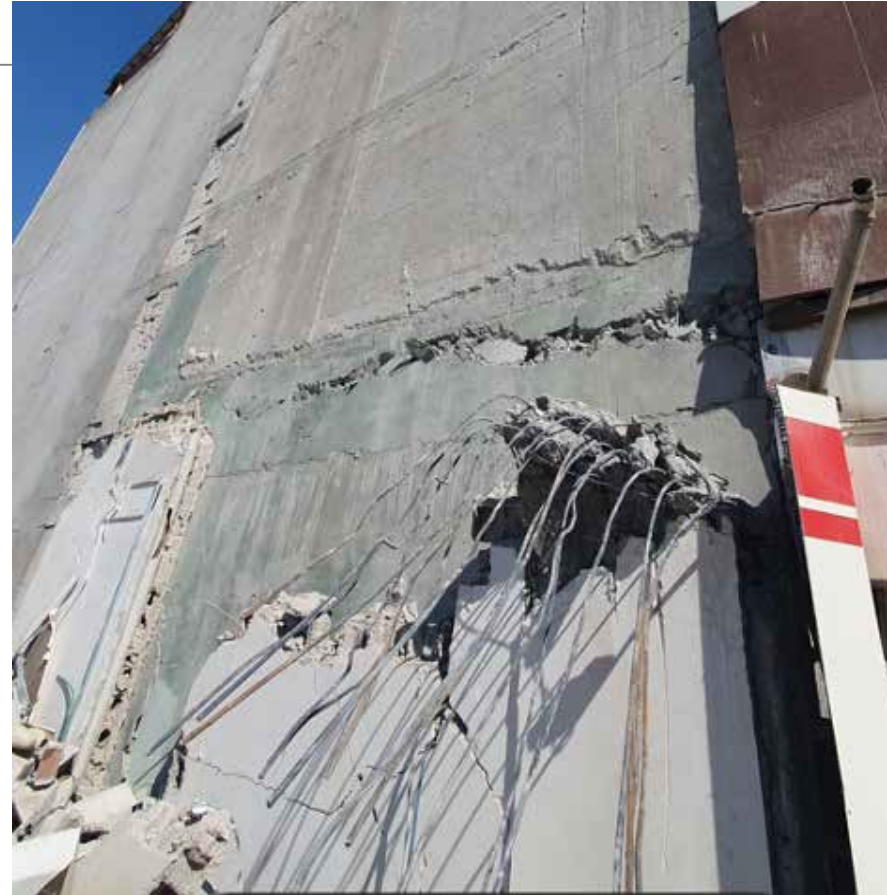
Shear wall damage – exterior view

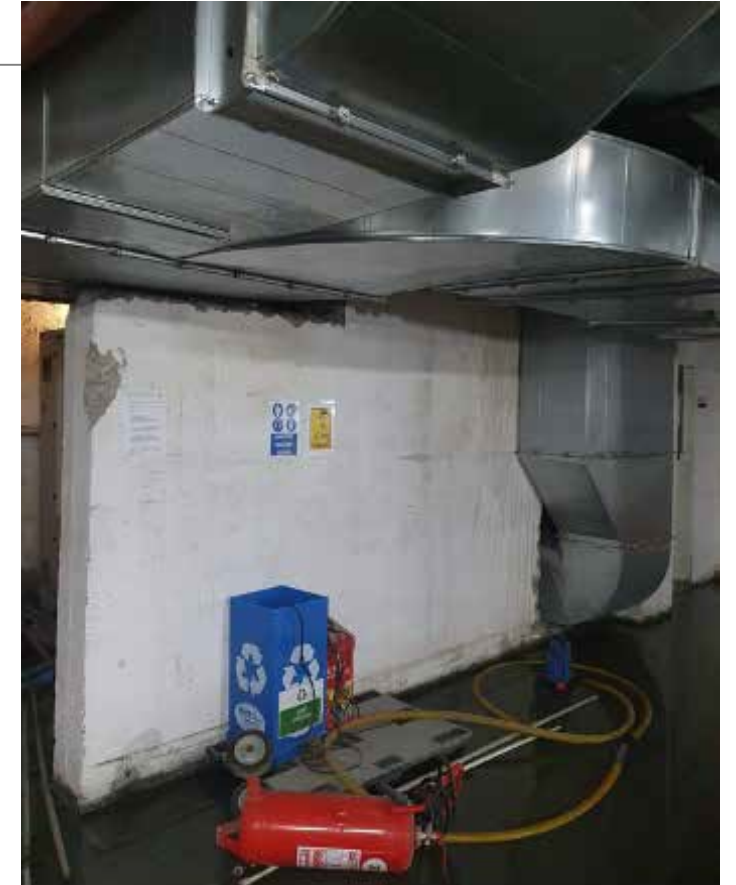
Ventilation system  
passing through the shear wall!!!

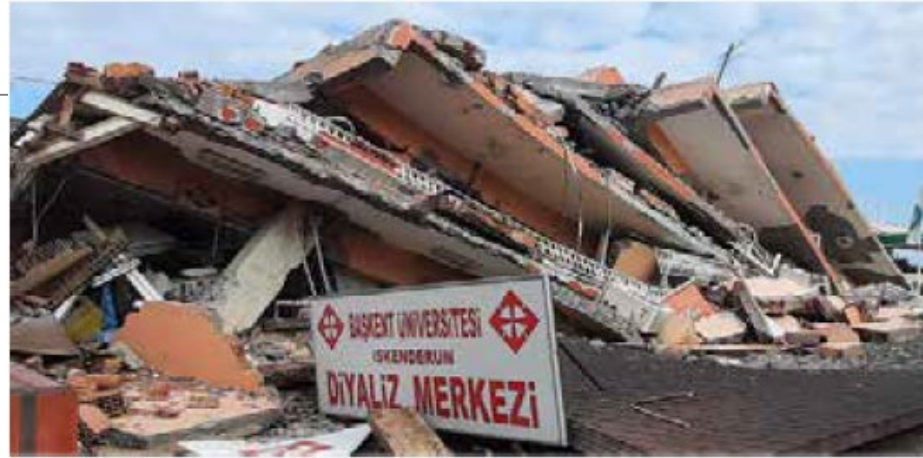
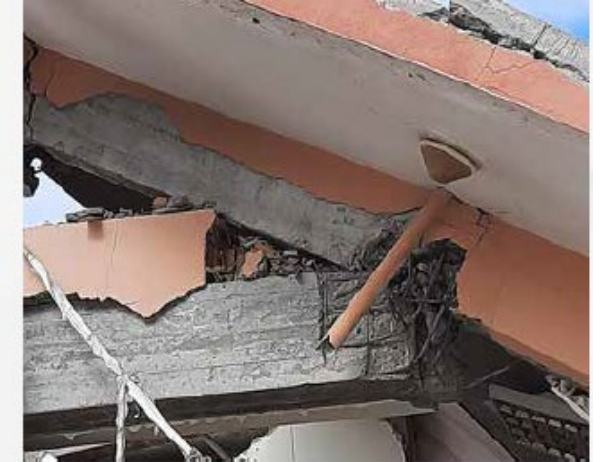
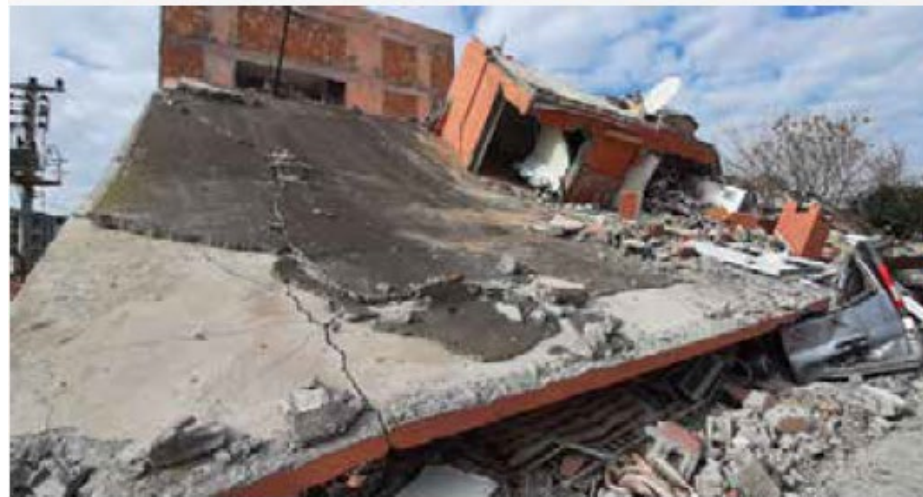
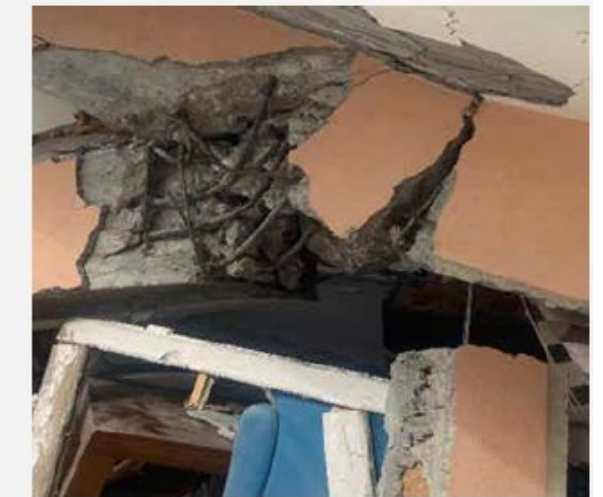
## Hatay, Private University Dialysis Center

Designed as residential,  
used as medical center.

**Completely collapsed!**

- Substandard reinforcement
- Poor concrete quality
- Weak column-strong beam

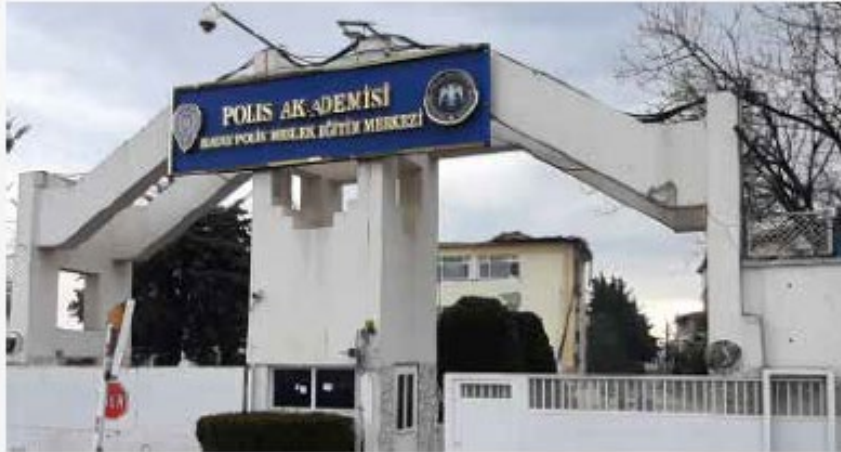
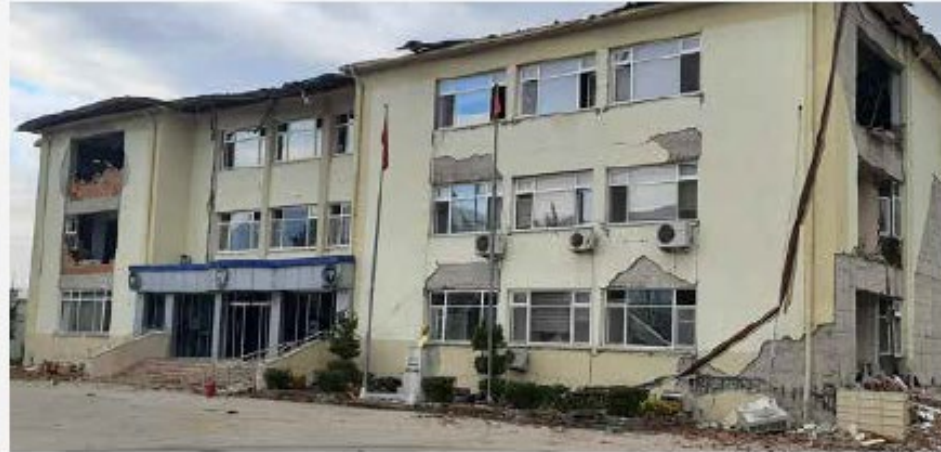
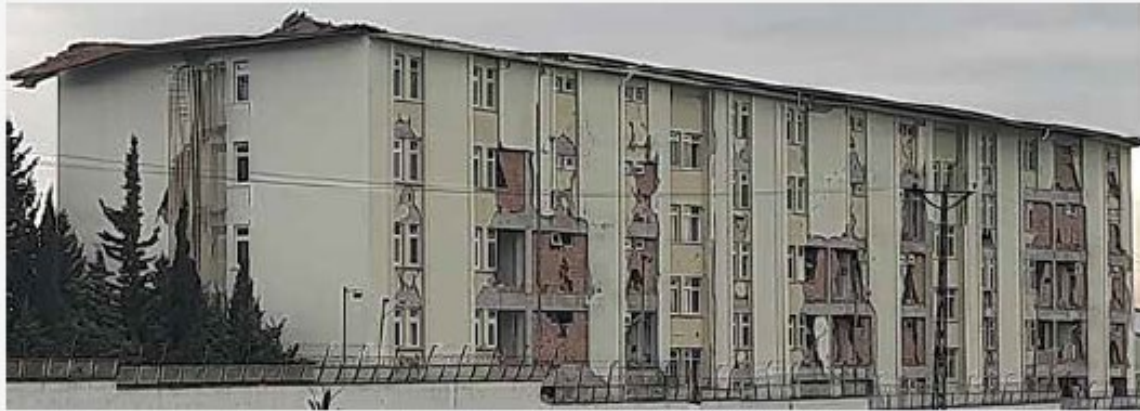
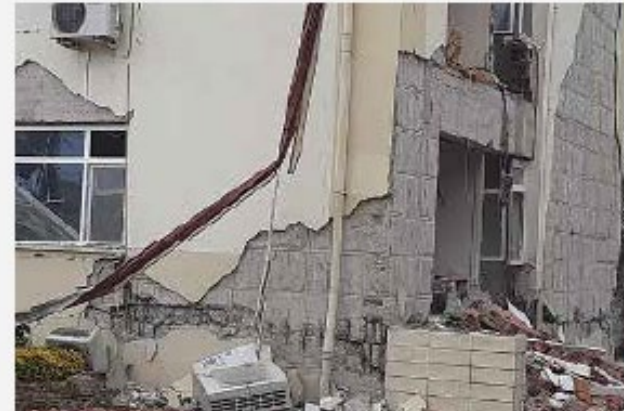
## Hatay, Police Academy

### Heavy Damage

- Inadequate clear cover
- Lack of boundary detailing
- Inadequate lap length
- Lack of transverse reinforcement
- Infill wall damage

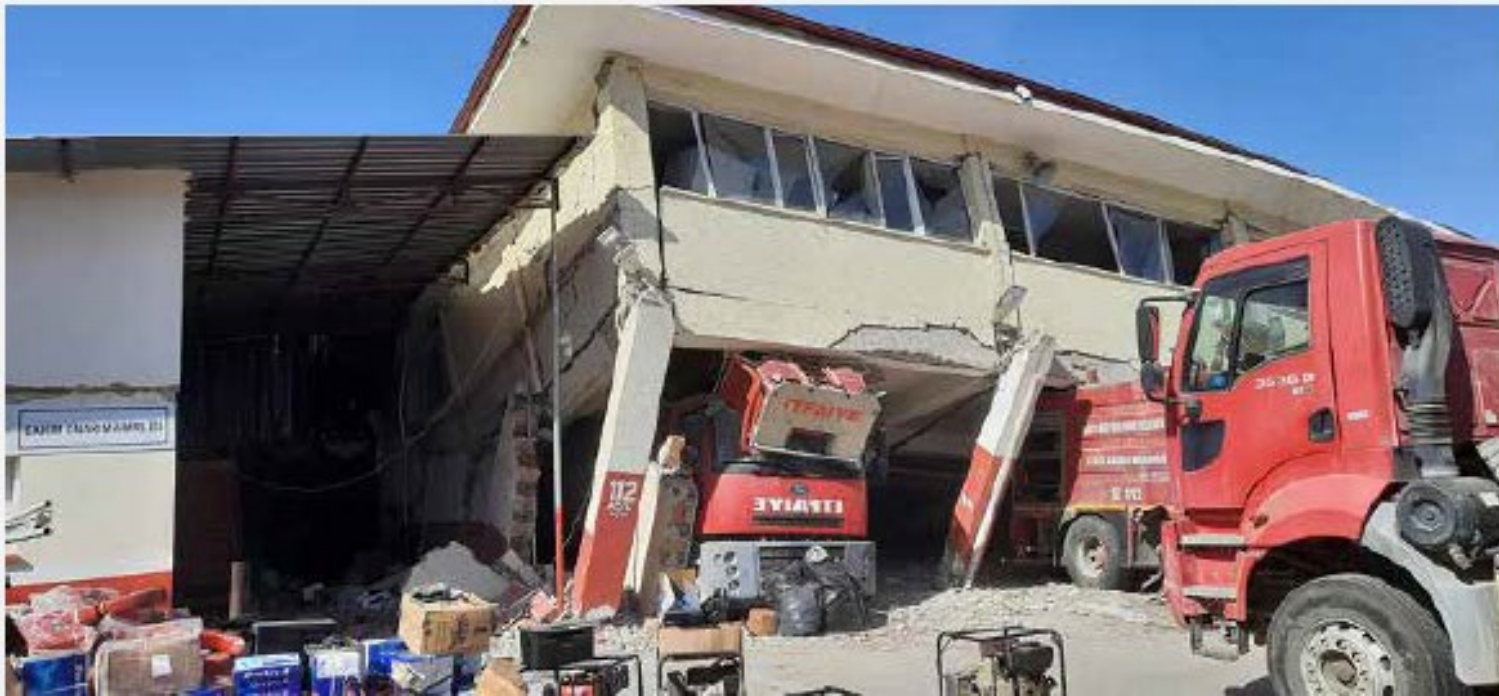
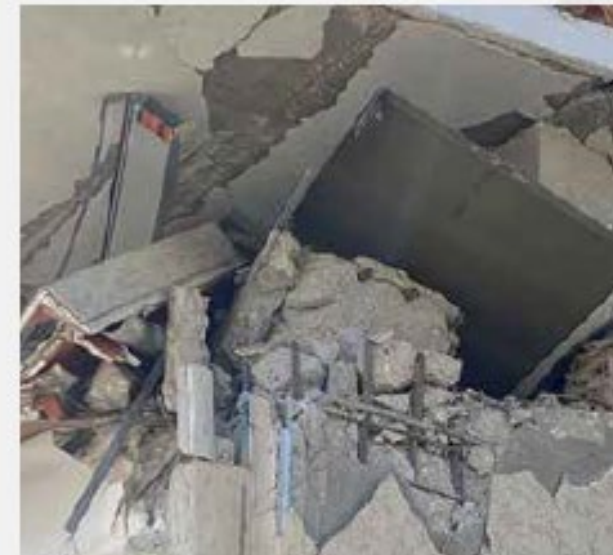
## Hatay – Antakya Fire Station

**Collapsed!**

- Higher first story height
- Soft story collapse
- Weak column-strong beam
